BOG BUSTERS

UNITED STATES ARMY TRANSPORTATION BOARD
Fort Eustis, Virginia
June 1963

Project TCB-62-183-EO, BOG BUSTERS, was an environmental operation conducted in Alaska during May and June 1962. The primary objective of the project was to determine the capabilities of selected tracked vehicles to traverse muskeg after the spring thaw.

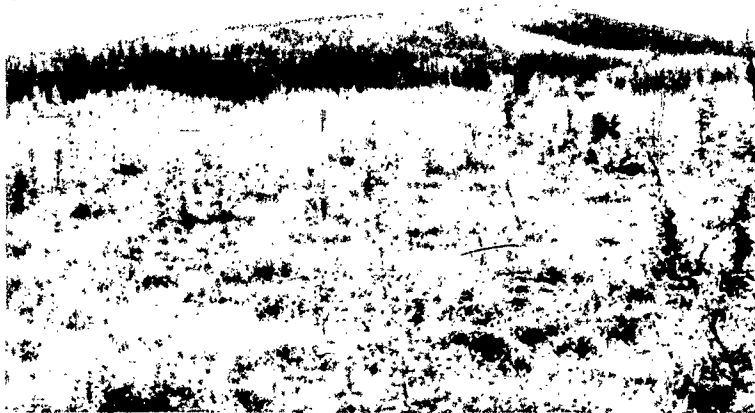
Figure 3. Typical terrain in Tolovana River area.

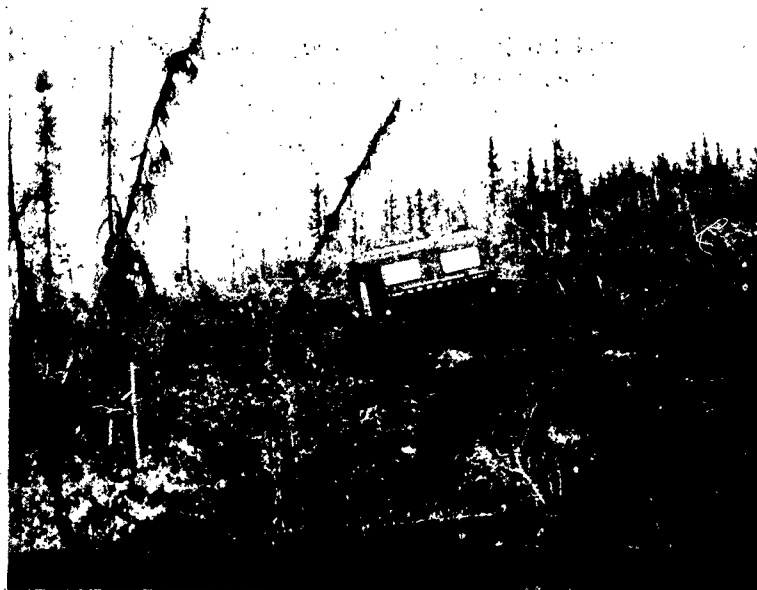
(2) Gradeability. Ravines and steep slopes did not present a problem to the RN 110B. It has excellent traction in rough terrain. Figure 6 shows the vehicle descending a side slope at the Tolovana River test site. The vehicle easily climbed vertical objects up to 1 1/2 feet.

Figure 6. RN 110B descending 30-percent side slope in Tolovana River area.

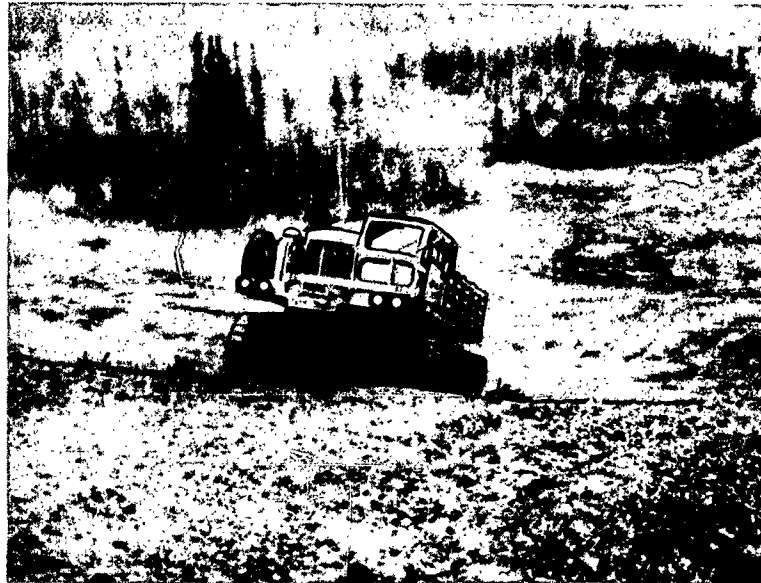
(6) Slope tests. Slope tests were made with the vehicle when it was both unloaded and loaded (fig. 10). The slopes were traversed without difficulty. The results of the tests were:

Figure 10. Carrier RN 110D-2 climbing an estimated 30-percent slope on OATA Red Course.

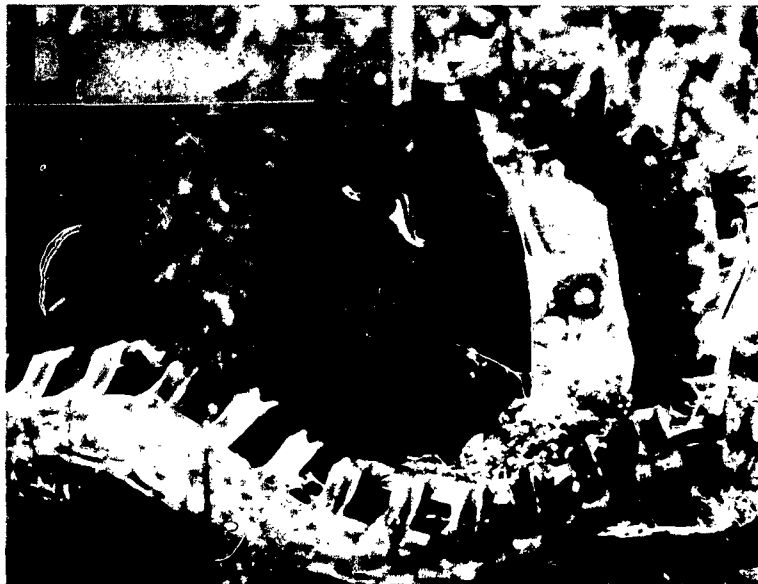
The track of the RN 110D-2 was thrown once during this evaluation (fig. 12). It happened when the vehicle was going through a wooded area in which downed trees and stumps were abundant. Generally, it takes three men 2 to 3 hours to reinstall a track. In this instance, it required four men approximately 5 hours to reinstall the track. The rough terrain in which the vehicle was located when the track was thrown prevented

Figure 12. Track of RN 110D-2 thrown as vehicle traversed wooded area.

the track from being laid out properly. The vehicle as well as the track had to be moved several times to find ample space in which to maneuver the vehicle onto the track.

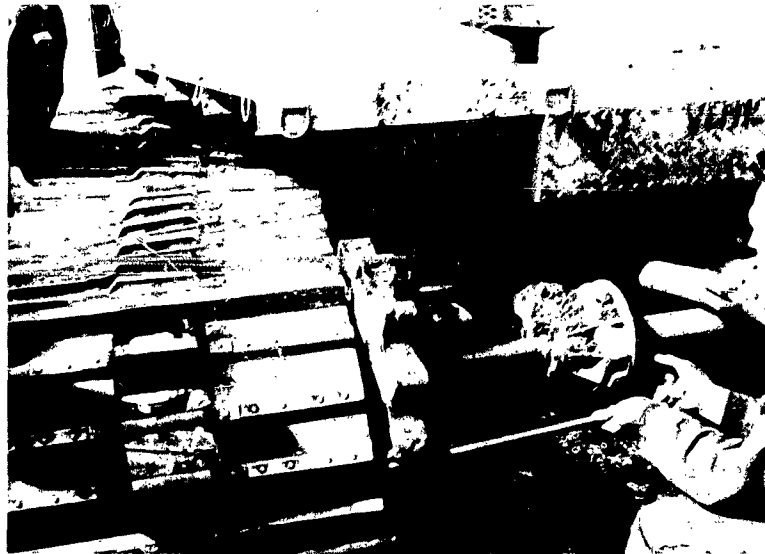
Figure 22. Reinstalling left track of Trackmaster.

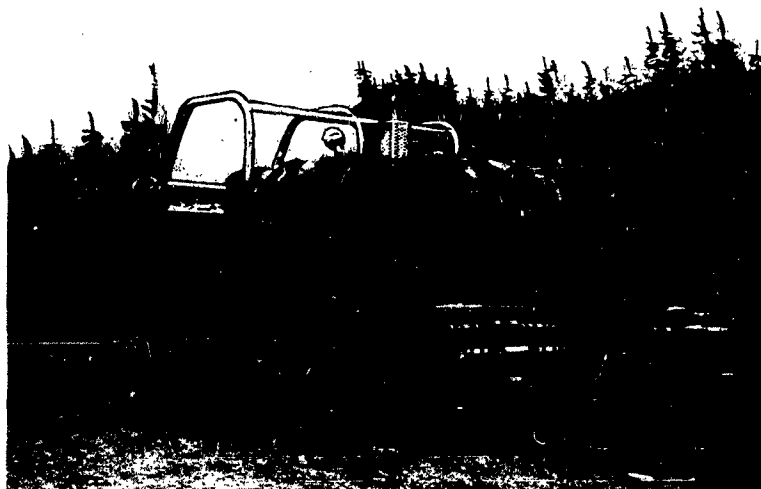
The open cab on the vehicle does not protect the driver and passenger from precipitation, falling objects, and overhanging tree limbs and brush along the trail. The short cargo bed allows mud and debris to be thrown on the cargo and into the open cab by the tracks (fig. 25).

Figure 25. Short cargo bed allows mud and debris to be thrown on cargo and into cab by tracks.

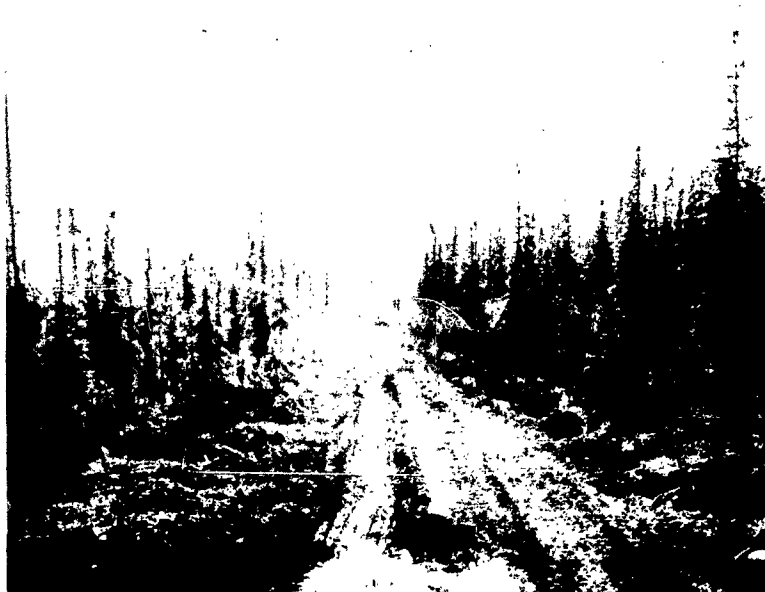
(1) Overall performance. The D-8 towing both empty and loaded Off-Road Trailers was able to traverse all of the terrain it encountered. It was first tested towing one empty trailer over disturbed muskeg. The surface of the course was relatively firm during the first pass. The vehicle, operated in third gear at 1300 rpm, encountered no difficulty negotiating the course although surface water as much as 4 feet deep was encountered. Track penetration on the first pass over the muskeg was 1 to 2 inches. The penetration, greater with each succeeding pass, reached a depth of 6 inches on the last pass. In succeeding trips over the course, the ground became extremely muddy (fig. 28), but the vehicle did not become immobilized. In the second test, the D-8 towed two trailers: one was empty and the other was loaded with approximately 24,000 pounds. The vehicle, operated in third gear at 1300 rpm, again negotiated the course without difficulty. The low

Figure 28. Muddy course traversed by D-8 tractor without difficulty.

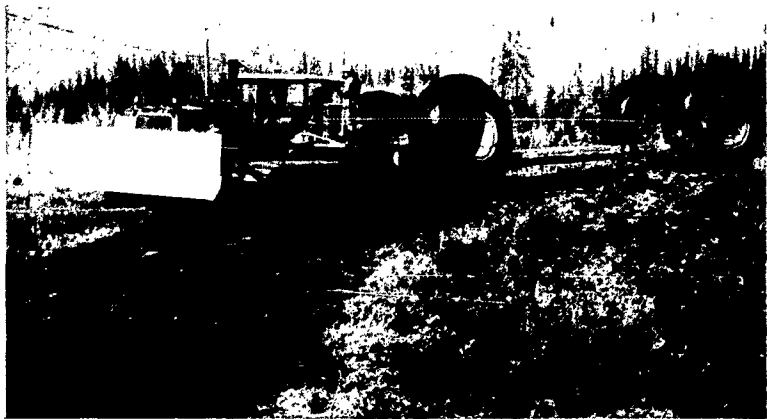
The steering systems of the tractor and the trailer are not compatible. The trailer does not track satisfactorily with the tractor. On a turn of only a few degrees, the front wheels of the trailer rub against the trailer frame. The incompatibility of the two steering systems severely limits the unit's maneuverability (fig. 29). The low maximum speed of the D-8 tractor further reduces its usefulness as a prime mover for the Off-Road Trailer.

Figure 29. D-8 tractor towing one Off-Road Trailer failed to negotiate this turn.
